Re: Matthiessen and Hegeler (M&H) Zinc Site Removal Action
LaSalle, LaSalle County, Illinois
Technical Direction Document No.: S05-0001-0908-009
Document Control No.: 729-2A-AESQ
Identification No.: B568
Work Order No.: 20405.012.001.0729.00

M&H Zinc Site Removal Action
October 2, 2009

ATTACHMENT D
PHOTOGRAPHIC LOG

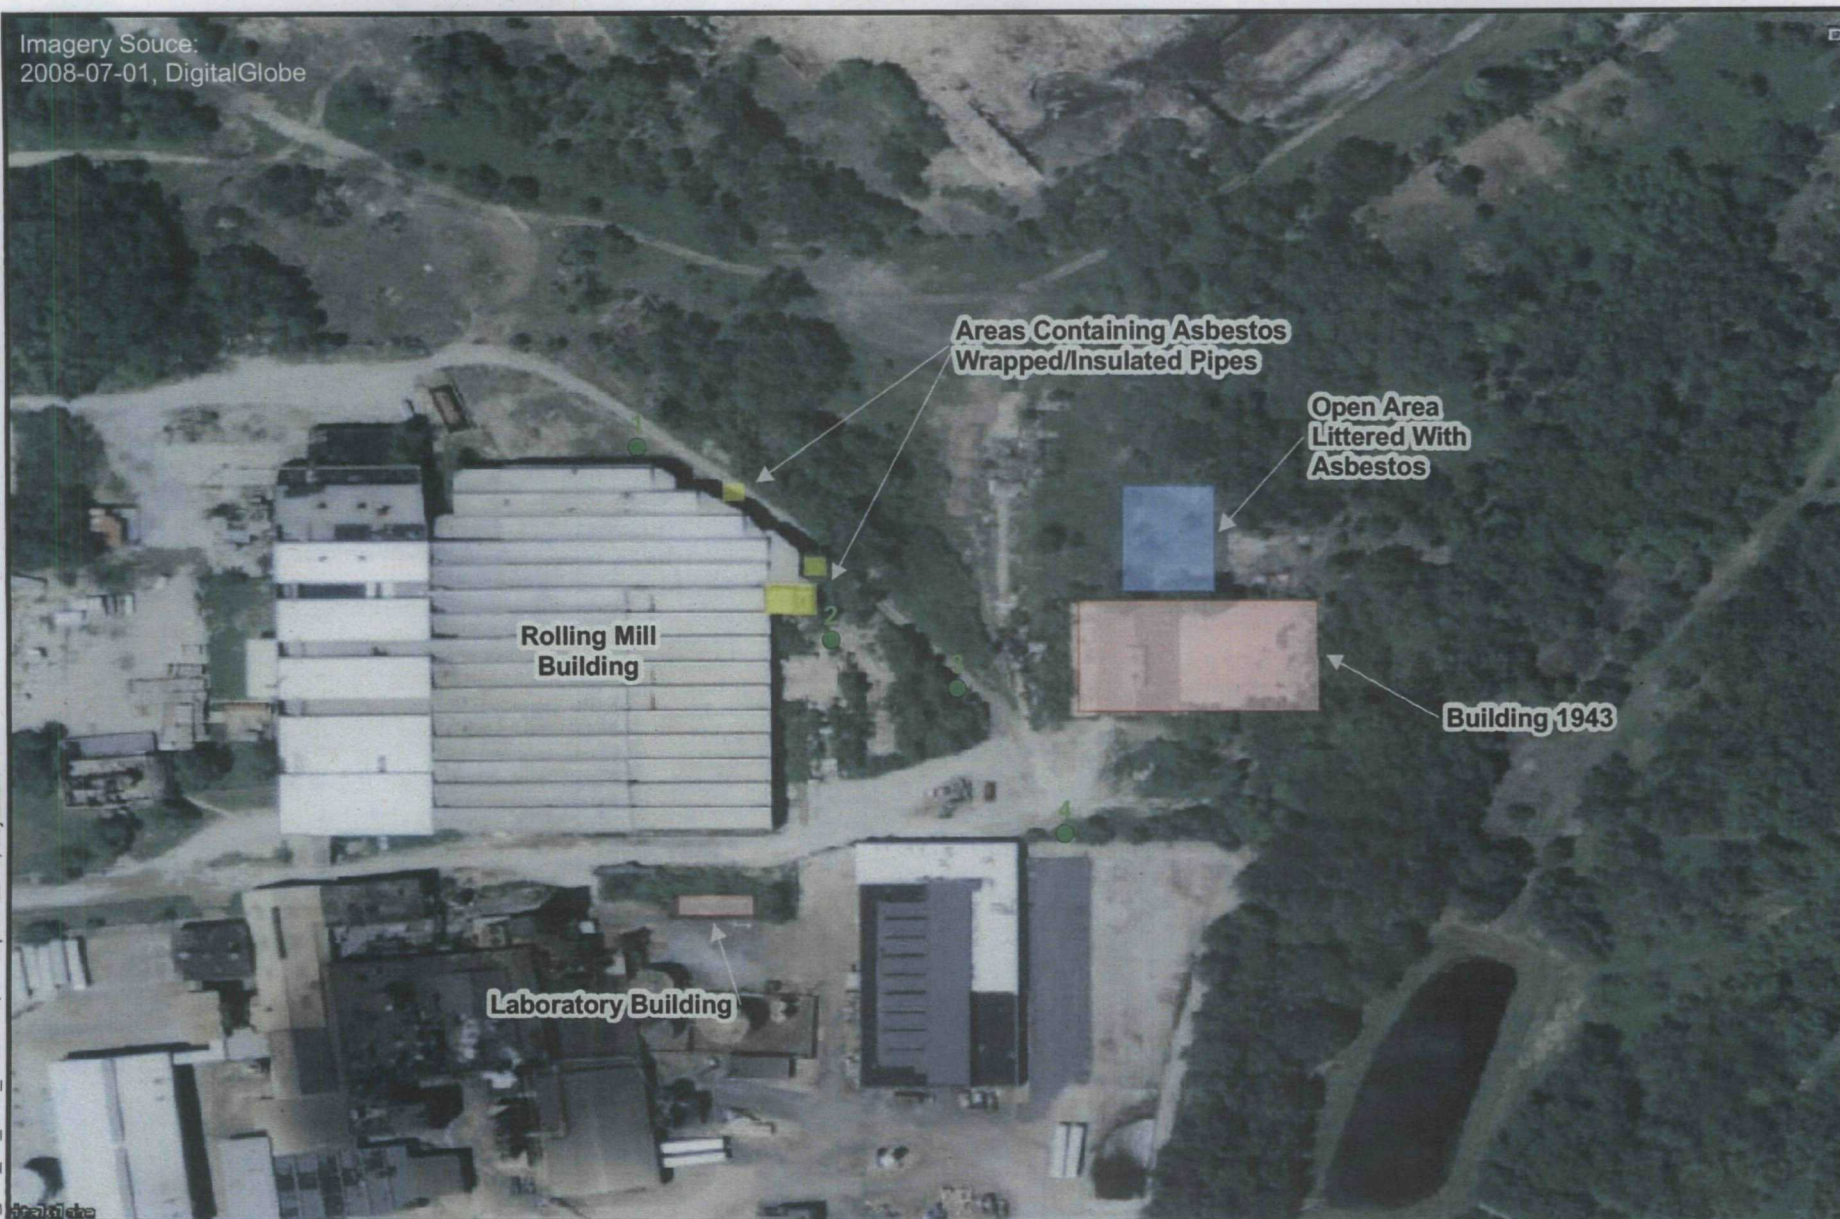
Air Sampling Station Locations for
Removal Action (9-10-09)
M & H Zinc Site Removal Action
LaSalle, LaSalle County, Illinois

- WESTON START conducted asbestos air sampling at four locations (Figure 4b in Attachment B). Air sampling station 3 was moved from the field location to the laboratory building during the day.
- ER collected three personal asbestos air samples during the abatement, ACM floor tile removal, and ACM removal activities north of Building 1943.

WESTON START conducted perimeter air sampling at four designated locations around the work areas (Figures 4a, 4b, 4c, and 4d in Attachment B). Air samplers ran for 6 to 9 hours on each of the 4 days. Daily perimeter air sampling for asbestos was conducted during the removal of asbestos pipe wrap/insulation and debris north of Building 1943. Daily perimeter air sampling for particulates, metals, and asbestos was conducted during demolition of the laboratory building.

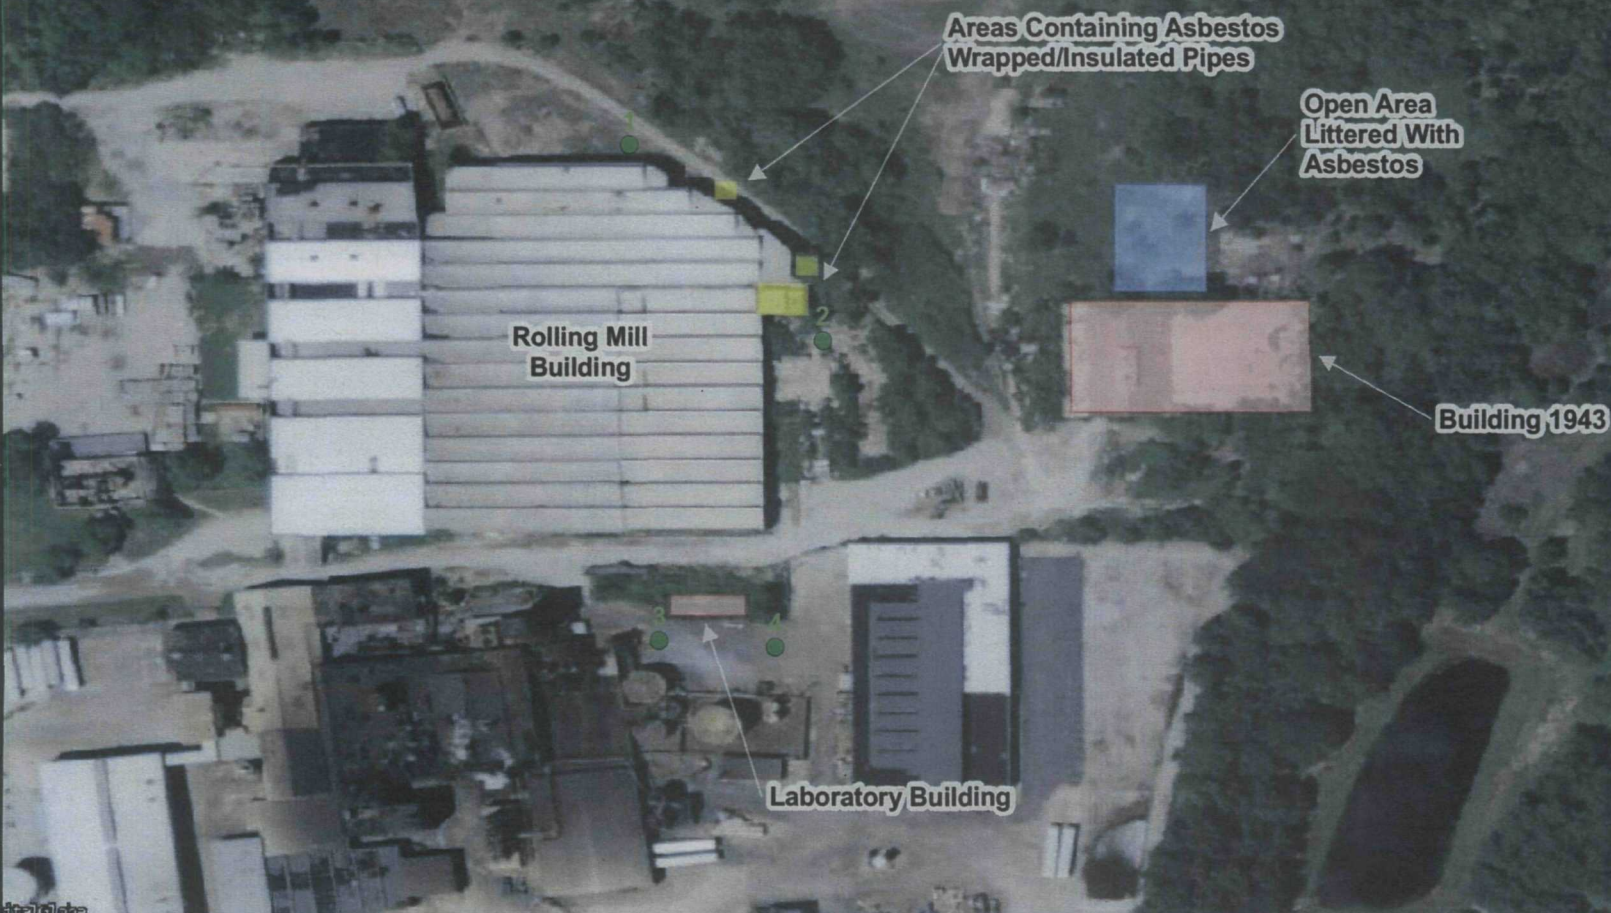
Figure 4c
Air Sampling Station Locations for
Removal Action (9-11-09)
M & H Zinc Site Removal Action
LaSalle, LaSalle County, Illinois

- Sampling Locations
- Locations 1-2 = asbestos analysis
Locations 3-4 = asbestos & metals/particulates analysis
- 0 200 Feet

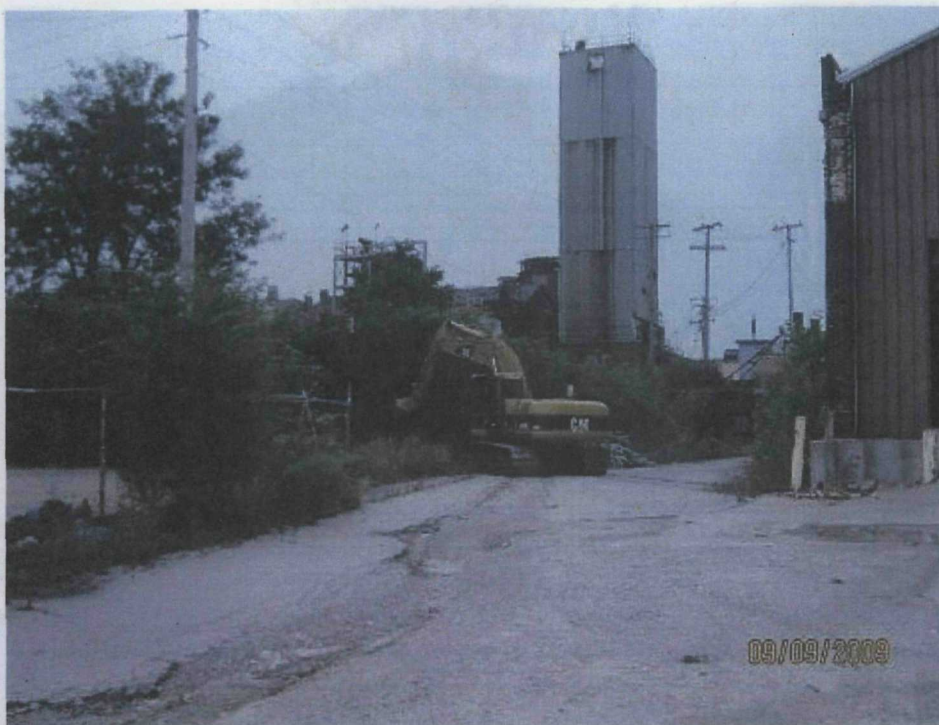
Photograph No.: 1

Subject: Clearing and grubbing of vegetation around laboratory building

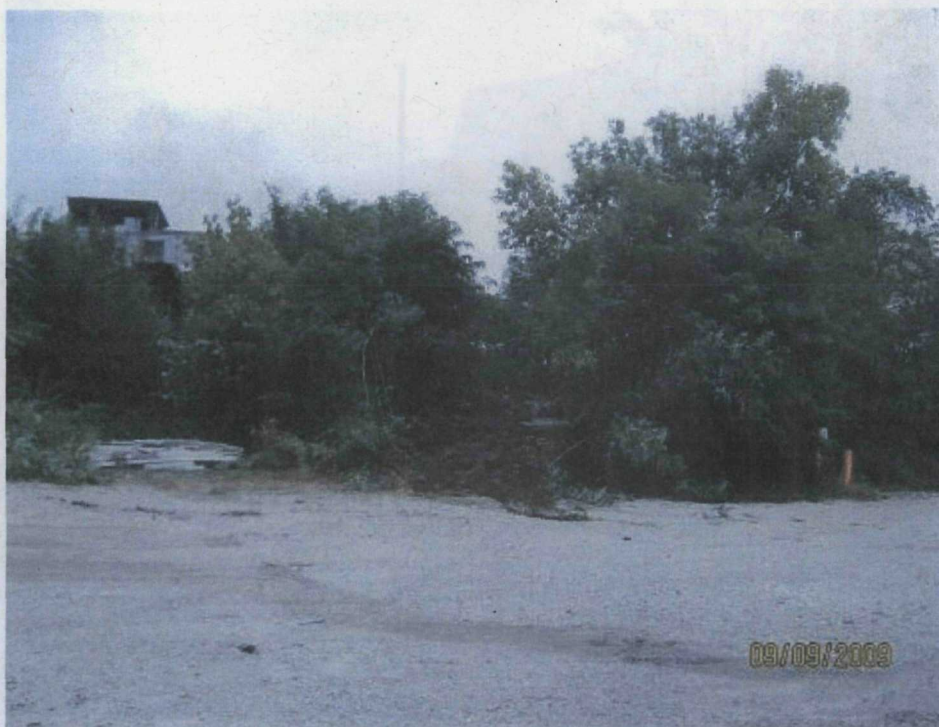
Photograph No.: 2

Subject: Clearing and grubbing of vegetation for access road

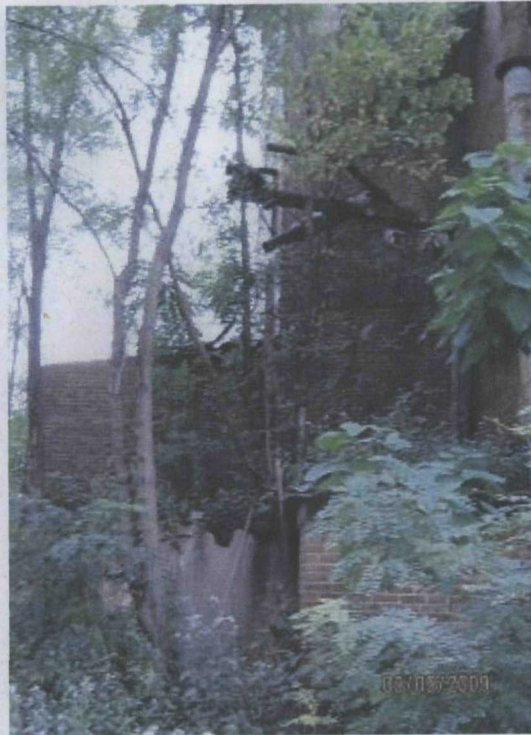
Site: M&H Zinc Site Removal Action, La Salle, IL
Photograph No.: 7
Direction: South
Subject: Asbestos pipe wrap/insulation abatement area

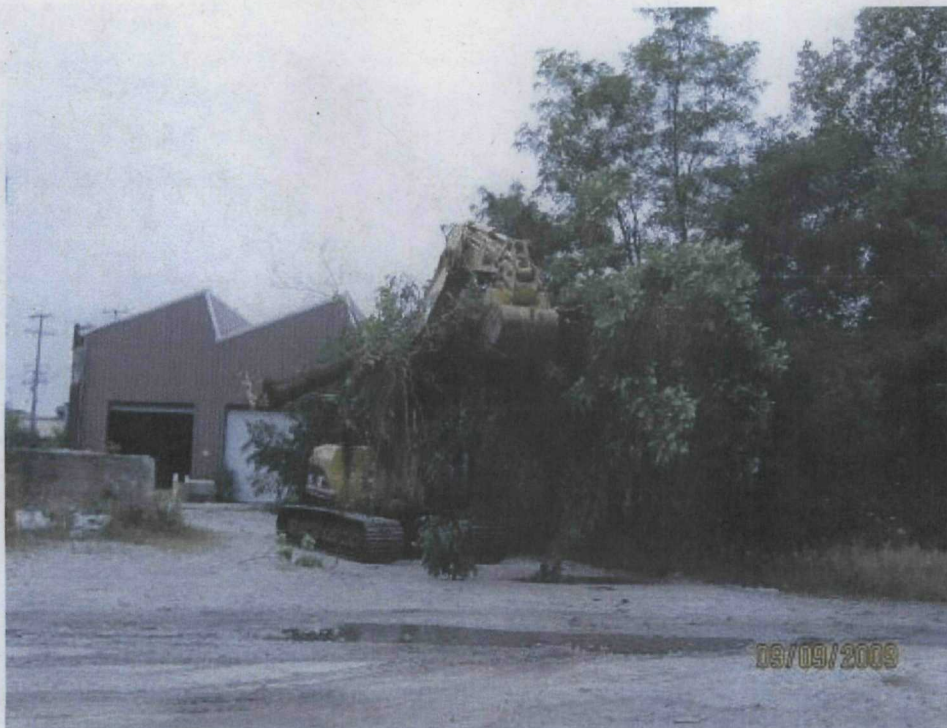
Site: M&H Zinc Site Removal Action, La Salle, IL
Photograph No.: 8
Direction: West
Subject: Clearing and grubbing of vegetation

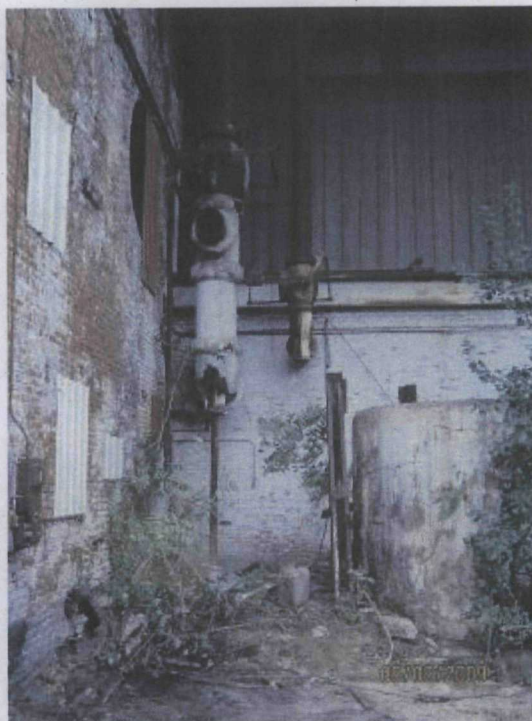
Site: M&H Zinc Site Removal Action, La Salle, IL
Photograph No.: 9
Direction: North
Subject: Asbestos pipe wrap/insulation abatement area

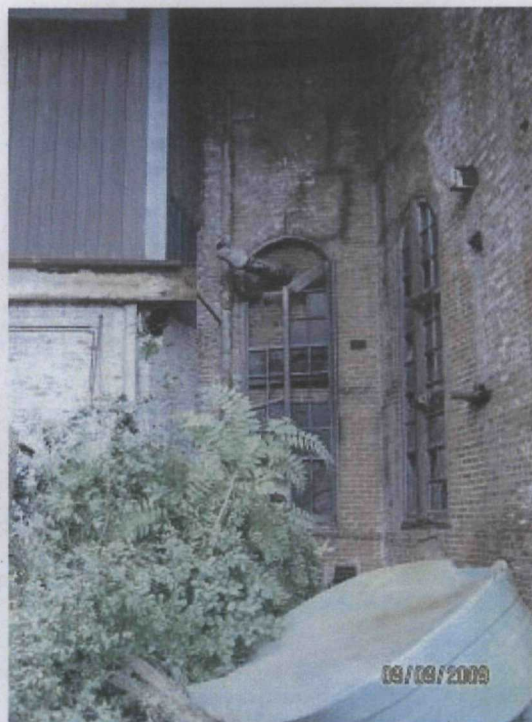
Site: M&H Zinc Site Removal Action, La Salle, IL
Photograph No.: 10
Direction: North
Subject: Asbestos pipe wrap/insulation abatement area

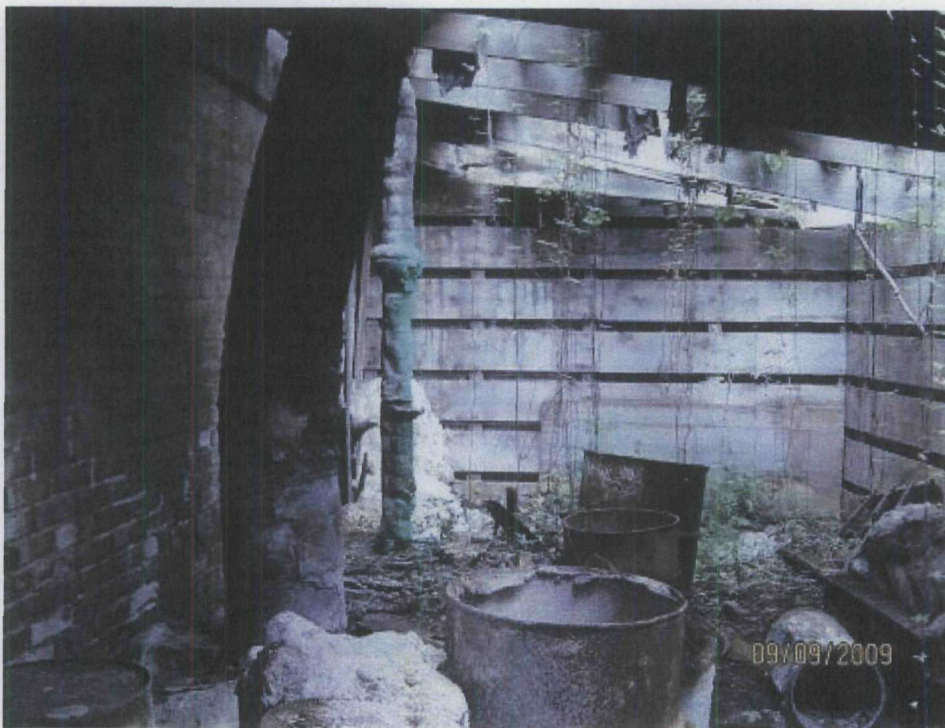
Photograph No.: 11

Subject: Asbestos pipe wrap/insulation abatement area

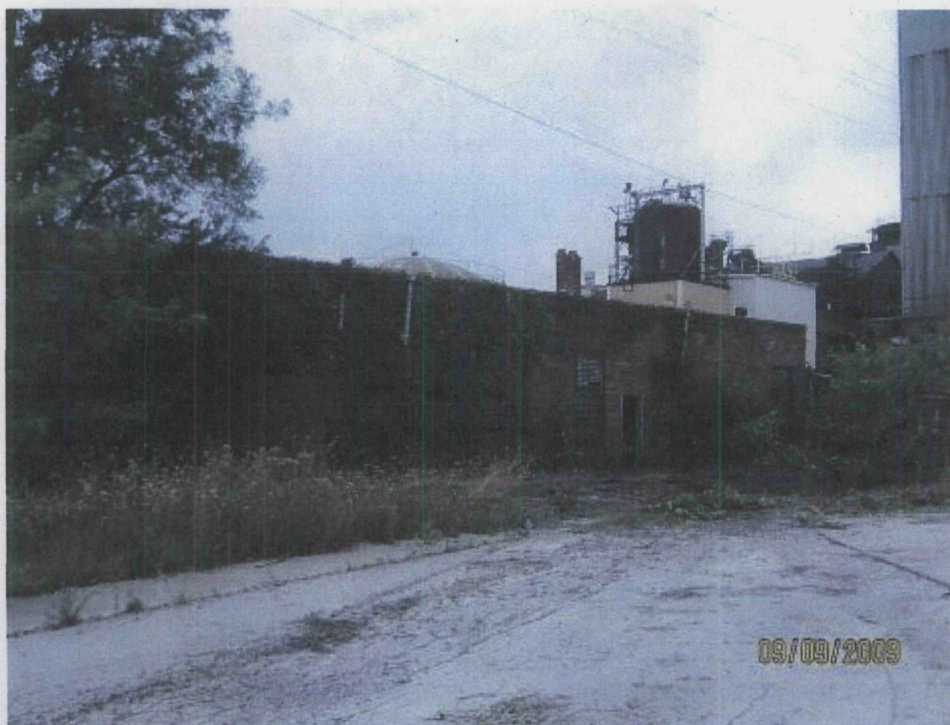
Photograph No.: 12

Subject: Laboratory building cleared of surrounding vegetation

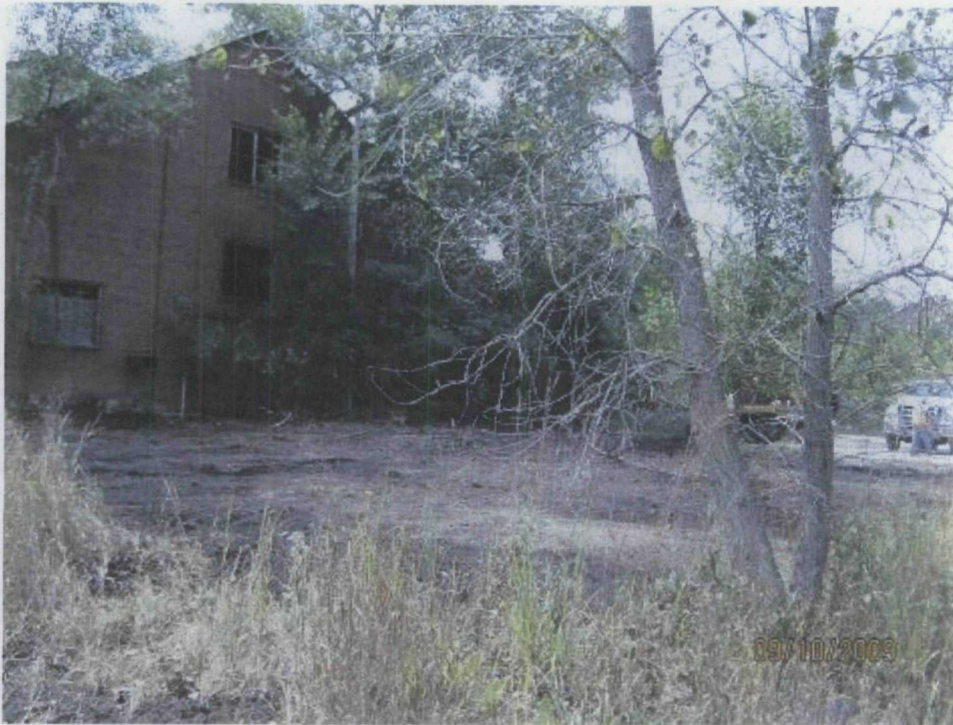
Site: M&H Zinc Site Removal Action, La Salle, IL
Photograph No.: 15
Direction: Southwest
Subject: Scraped field north of Building 1943

The ACM removal outside of the rolling mill building consisted of removing entire pipe sections using cutting tools. The ACM removal inside the laboratory building consisted of removing floor tiles using shovels and scrapers. The ACM and piping sections were placed in plastic bags and secured with duct tape or placed in 55-gallon plastic drums. Approximately 48 linear feet of friable asbestos pipe wrap was abated and disposed of with the construction debris containing friable asbestos. The ACM removal north of Building 1943 consisted of scraping approximately

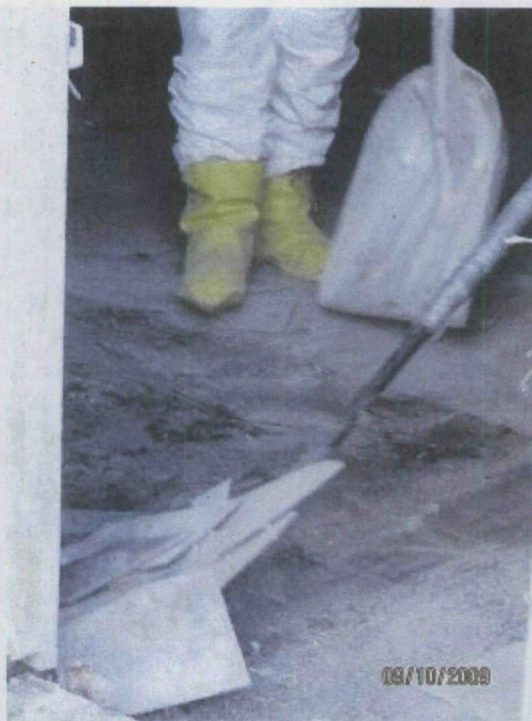
Site: M&H Zinc Site Removal Action, La Salle, IL
Photograph No.: 16
Direction: Southeast
Subject: Asbestos-containing floor tile removal in laboratory building

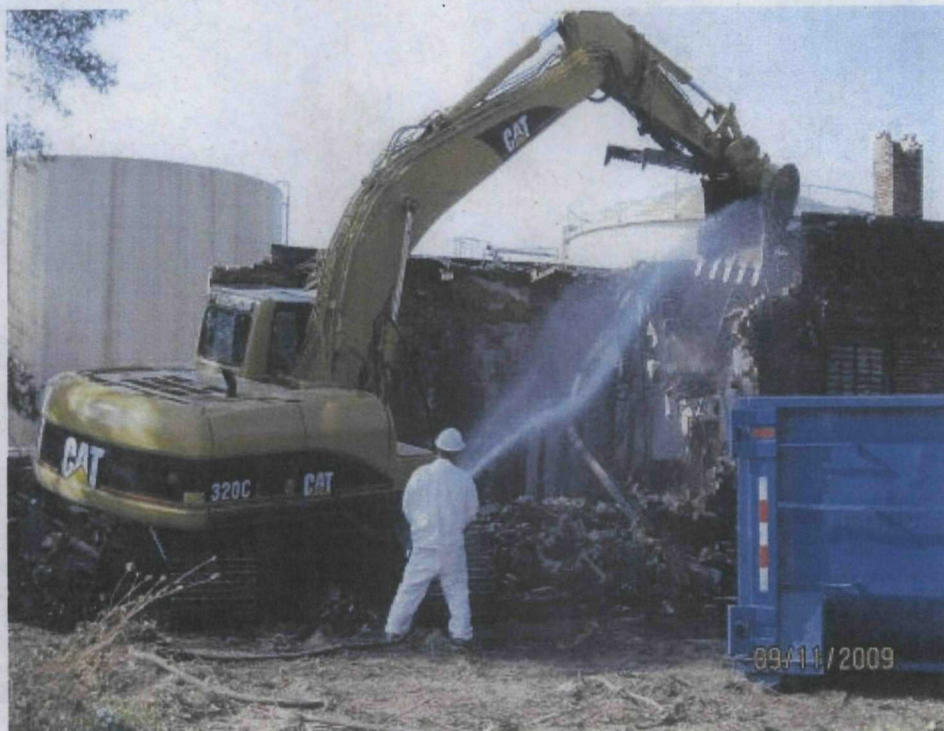
Site: M&H Zinc Site Removal Action, La Salle, IL
Photograph No.: 21
Direction: South
Subject: Dismantlement of laboratory building

Building demolition and debris segregation were accomplished using heavy equipment. Operators segregated the construction debris from scrap metal. ER used water hoses to wet the construction debris in order to minimize dust levels. Piles of construction debris were loaded into roll-off boxes and trucks and sent off site for disposal. Scrap metal was left on site. More details regarding waste disposal are presented below under "Disposition of Wastes."

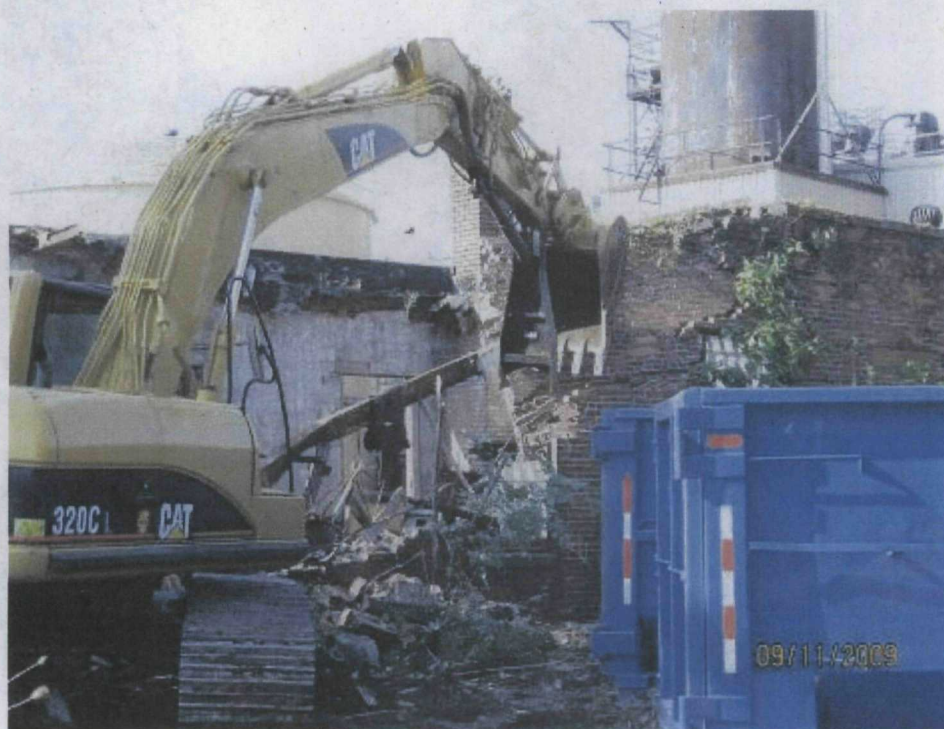
Site: M&H Zinc Site Removal Action, La Salle, IL
Photograph No.: 22
Direction: Southwest
Subject: Dismantlement of laboratory building

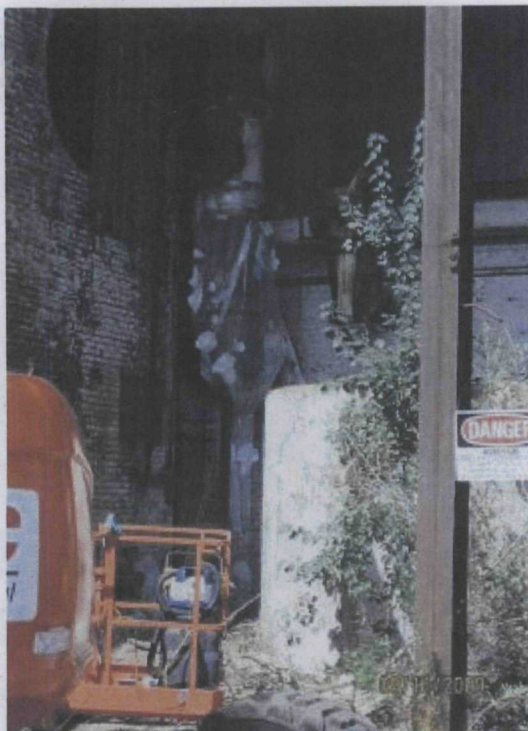
Site: M&H Zinc Site Removal Action, La Salle, IL
Photograph No.: 25
Direction: Northwest
Subject: Asbestos pipe wrap/insulation abatement area

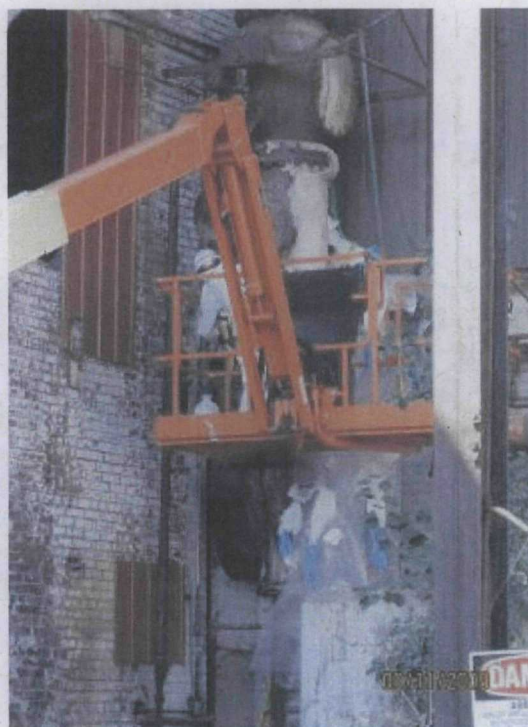
Site: M&H Zinc Site Removal Action, La Salle, IL
Photograph No.: 26
Direction: Northwest
Subject: Asbestos pipe warp/insulation abatement outside rolling mill building
